[La SFR vous informe] Risque d'incendie lors de l'utilisation de couvertures en IRM : un case report paru dans Radiology

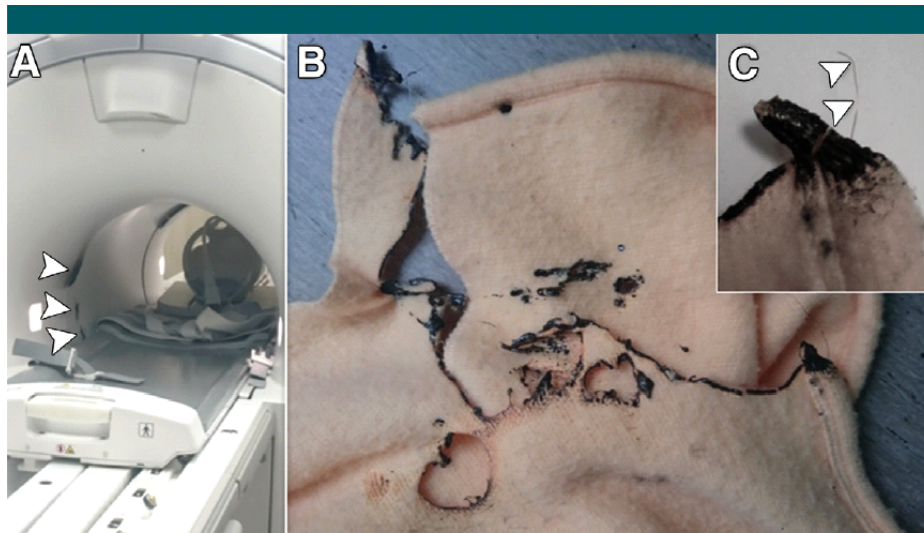
Une couverture qui prend feu lors d'un examen IRM : cet incident, jamais rapporté jusqu'ici, était dû à l'emploi par le fabricant d'un fil de guidage en cuivre au sein de l'ourlet. Cette technique de fabrication étant devenue fréquente, les auteurs recommandent de proscrire l'utilisation de couvertures lors des examens IRM.

Images show traces of smoke inside the, A, 3.0-T PET/MR imaging unit (arrowheads) related to, B, the combustion of a blanket due to the presence of, C, a small copper filament (arrowheads).
